## Appendix A

### Site Reconnaissance Photographs

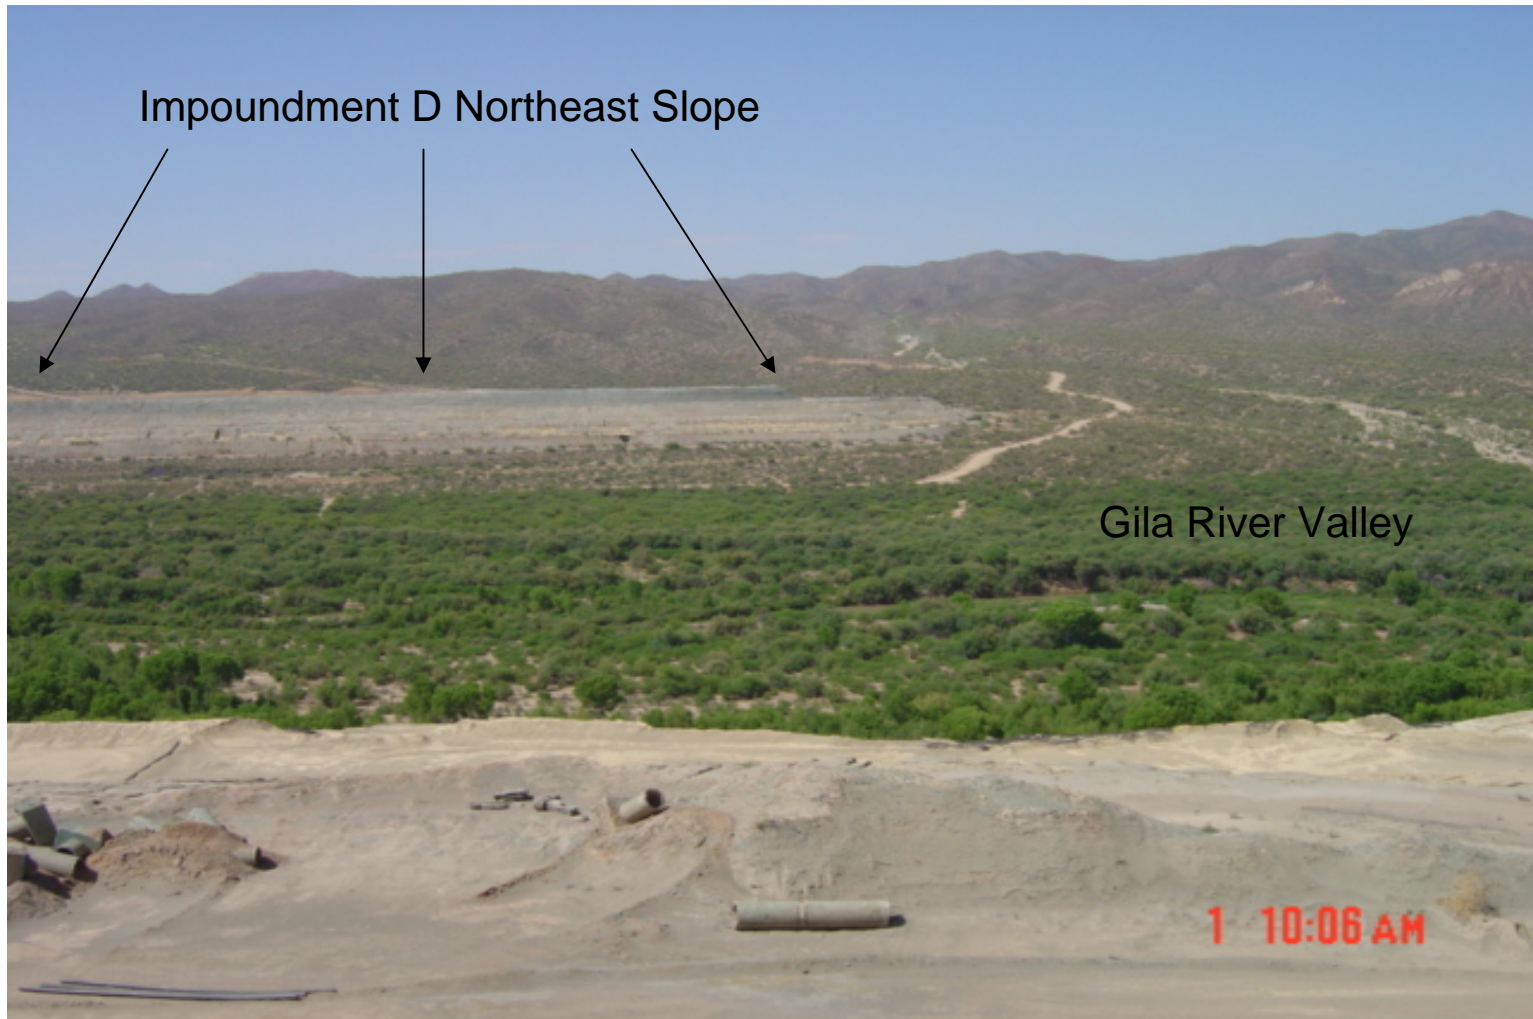
## Photograph 1

**View looking west to southwest at northeast corner of Impoundment D.  
Photograph taken from the northwest crest of Impoundment BC.**

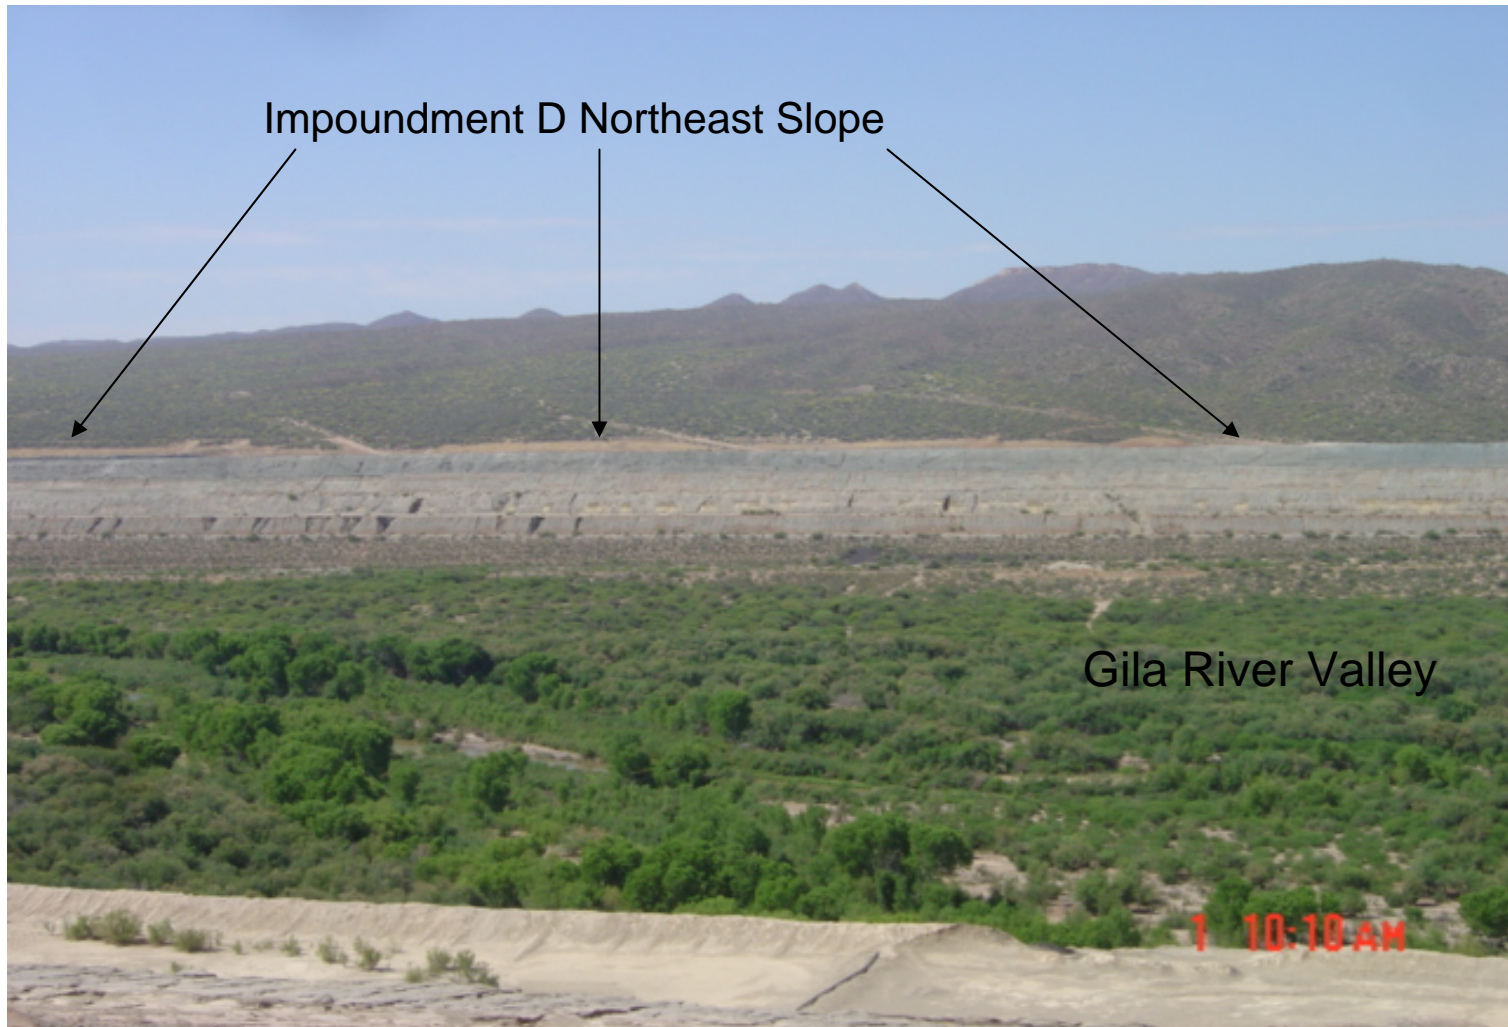
## Photograph 2

**Photographs 2 through 5 present panoramic view of Impoundment D's northeast slope, viewed from northwest to southeast.**

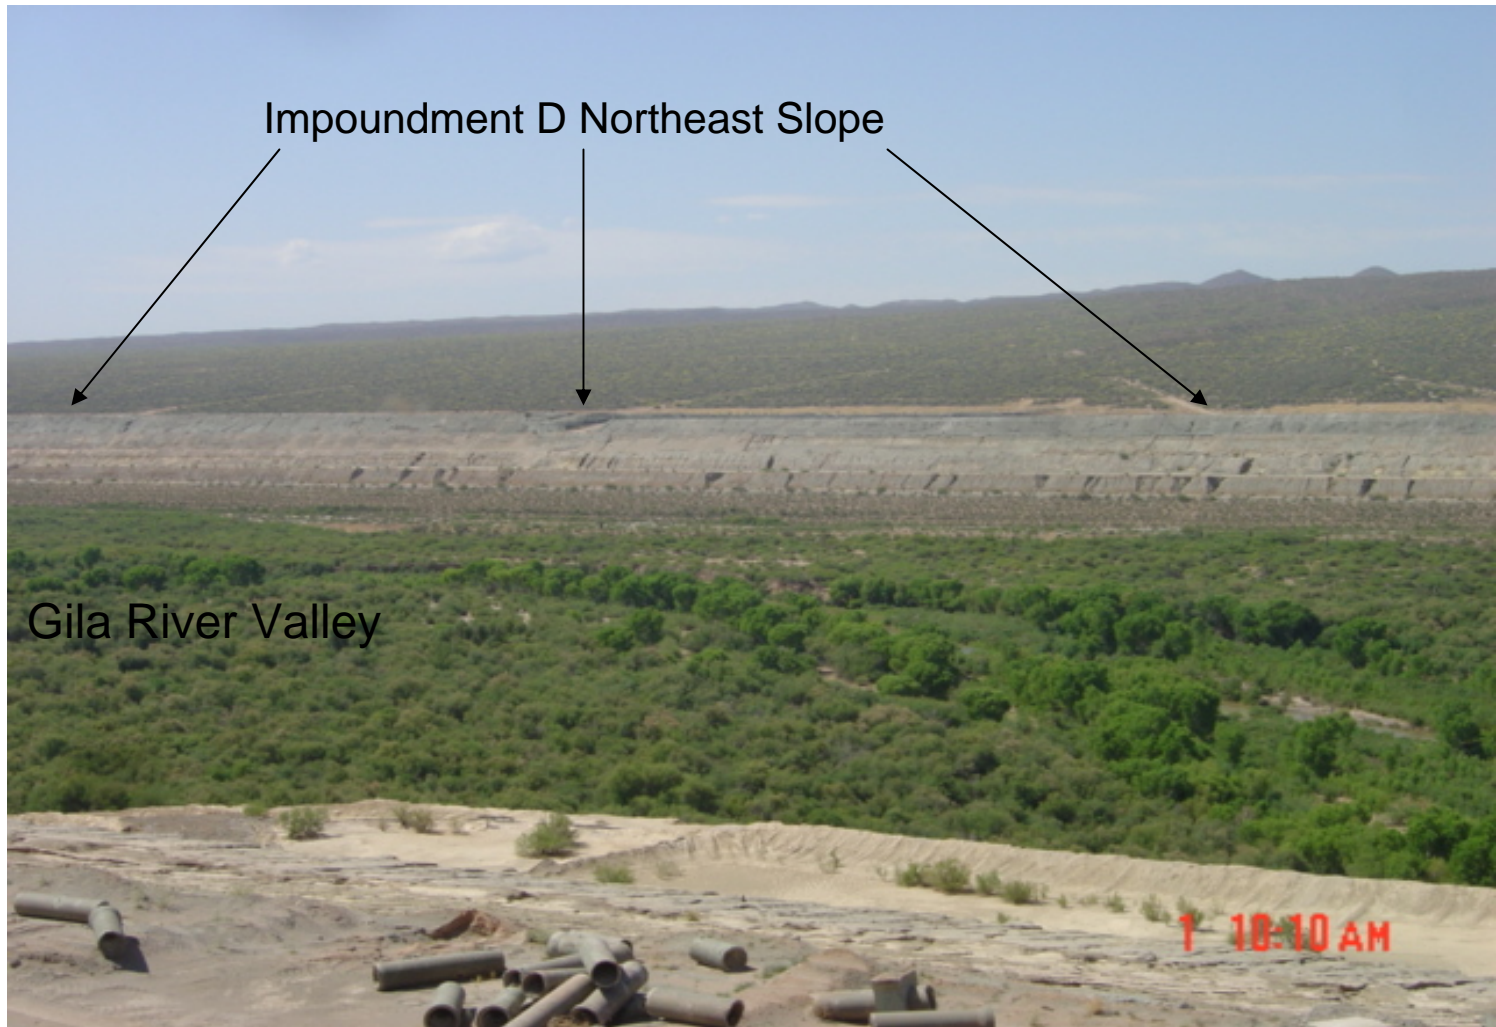
### Photograph 3

**Photographs 2 through 5 present panoramic view of Impoundment D's northeast slope, viewed from northwest to southeast.**

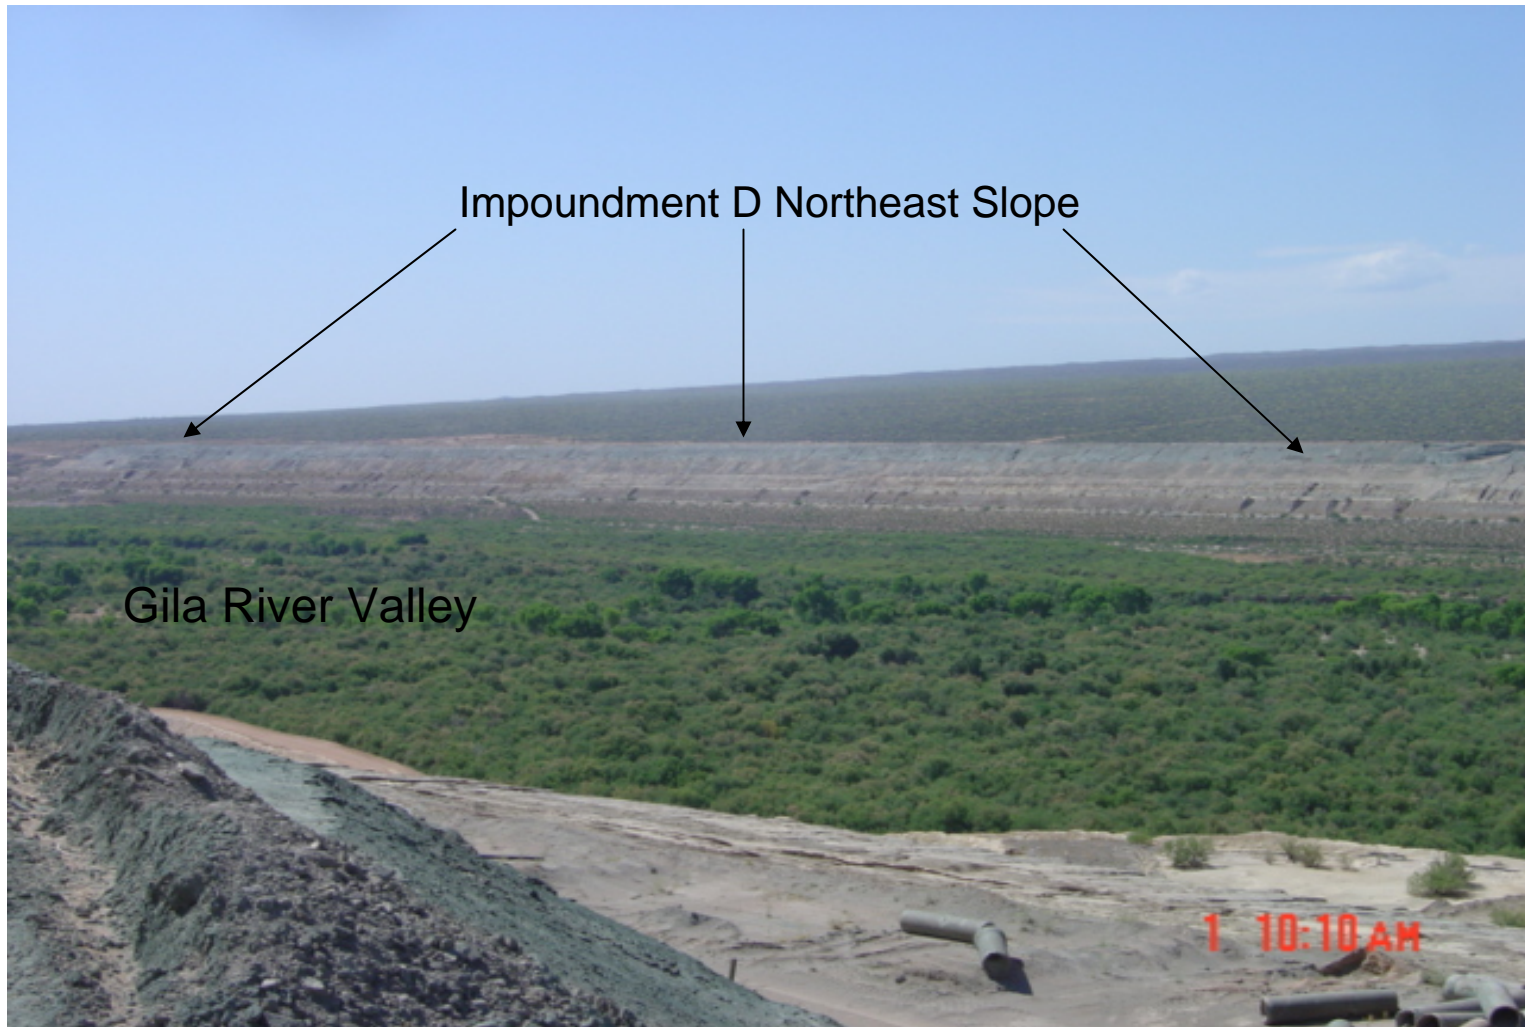
**Photograph 4**

**Photographs 2 through 5 present panoramic view of Impoundment D's northeast slope, viewed from northwest to southeast.**

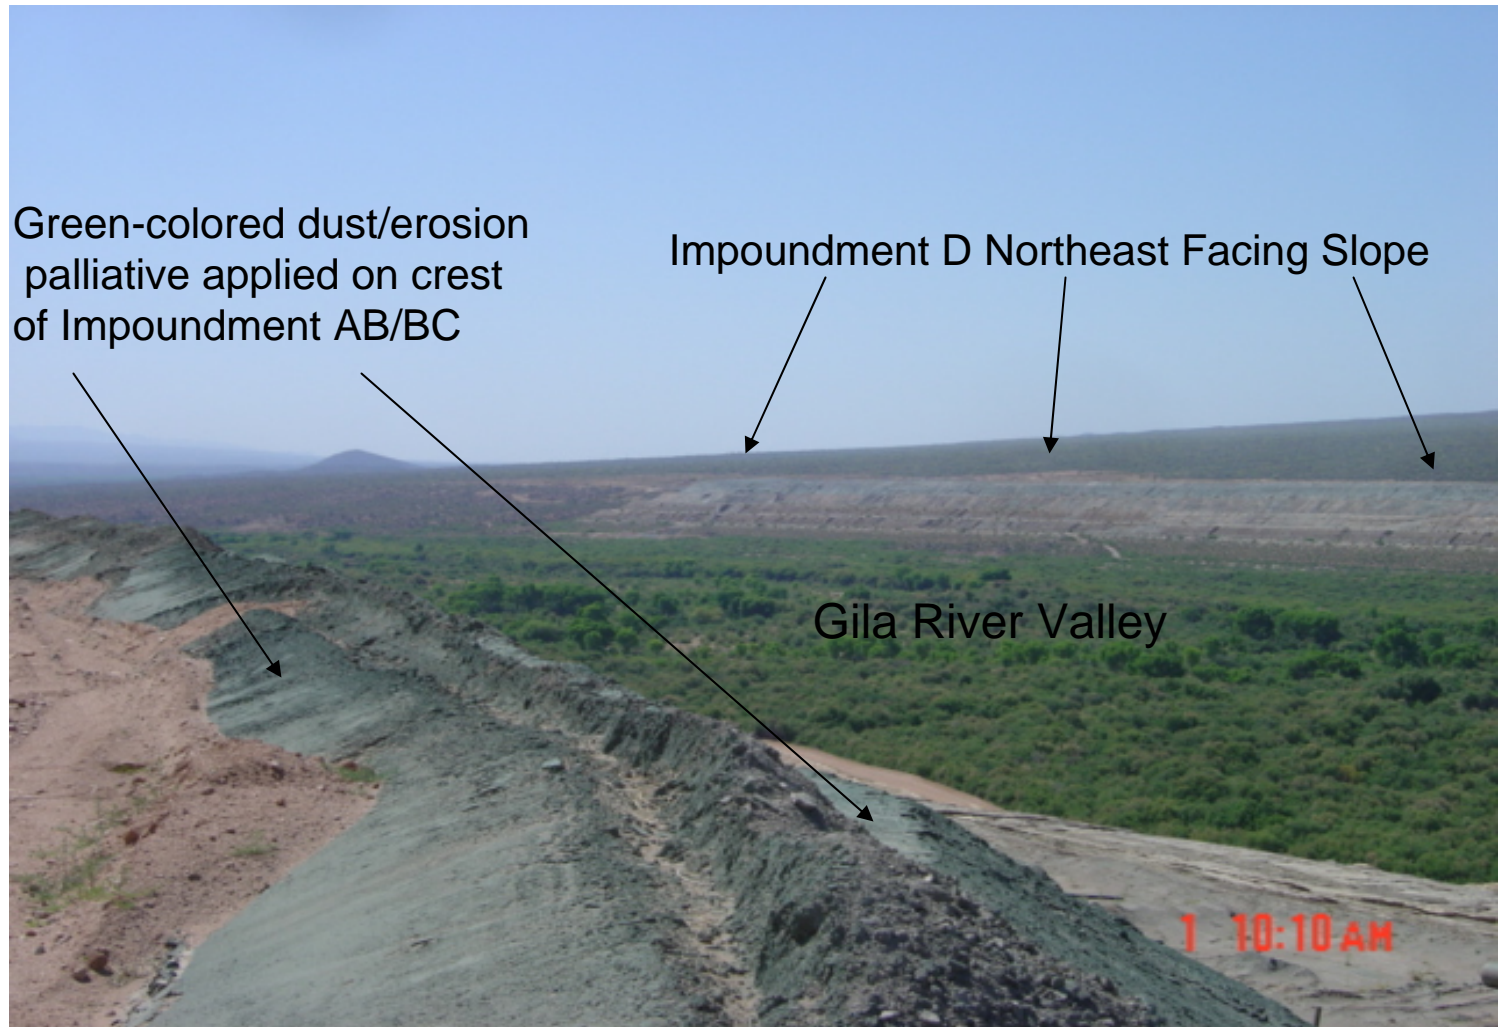
**Photograph 5**

**Photographs 2 through 5 present panoramic view of Impoundment D's northeast slope, viewed from northwest to southeast.**

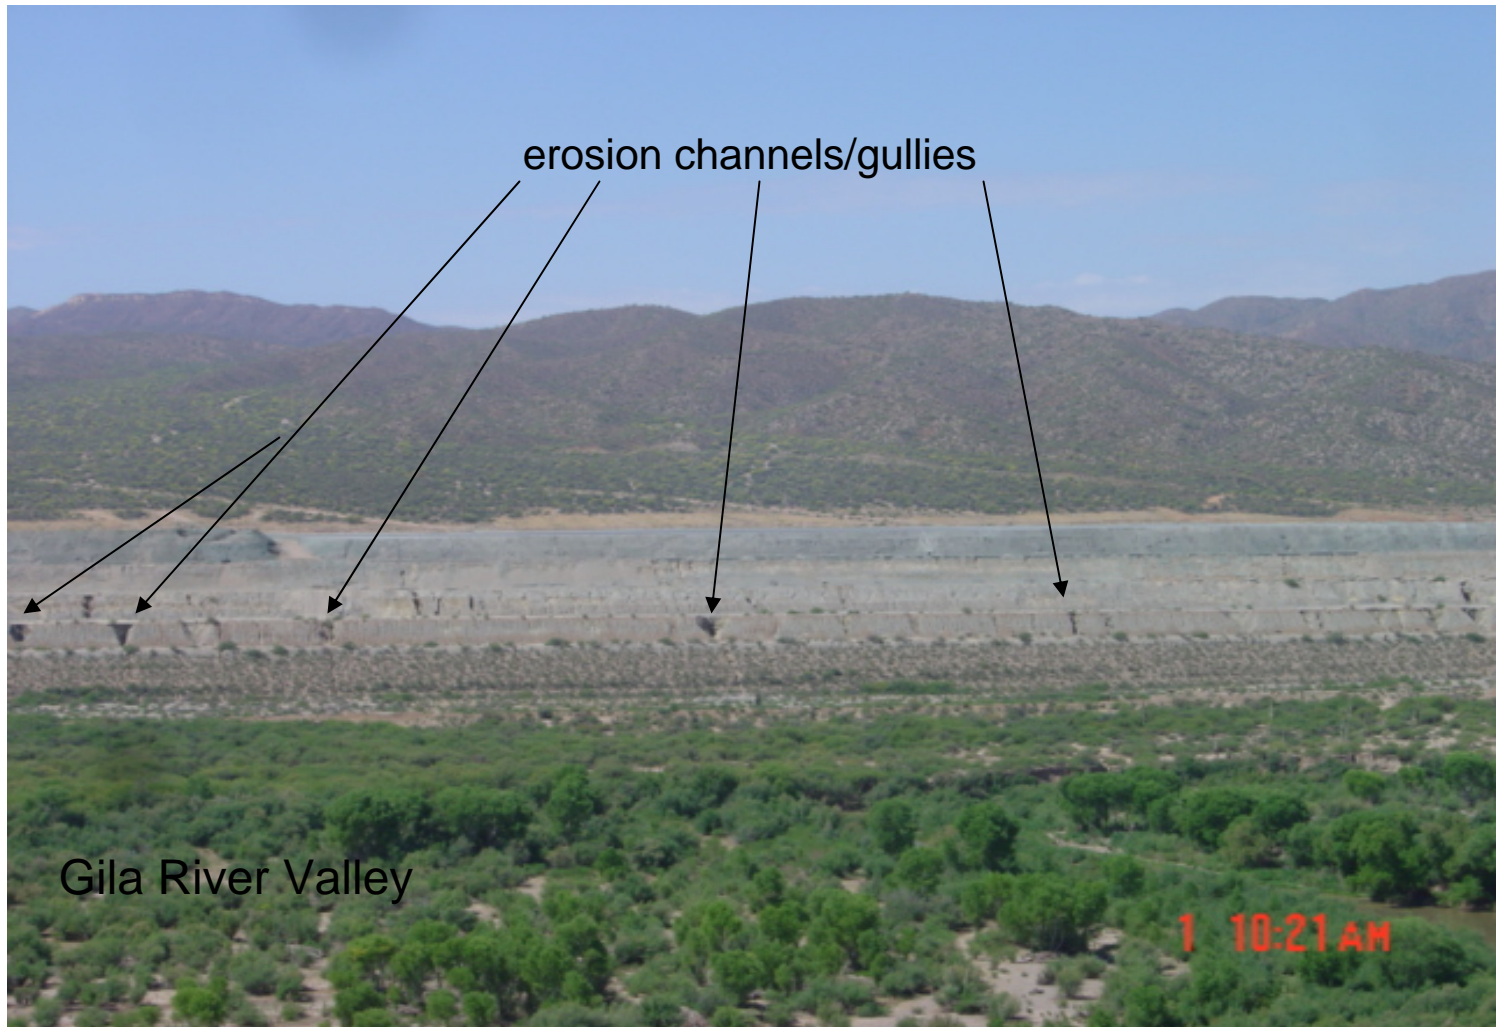
**Photograph 6**

**Closer view of Impoundment D northeast slope showing erosion features along lower bench face.**

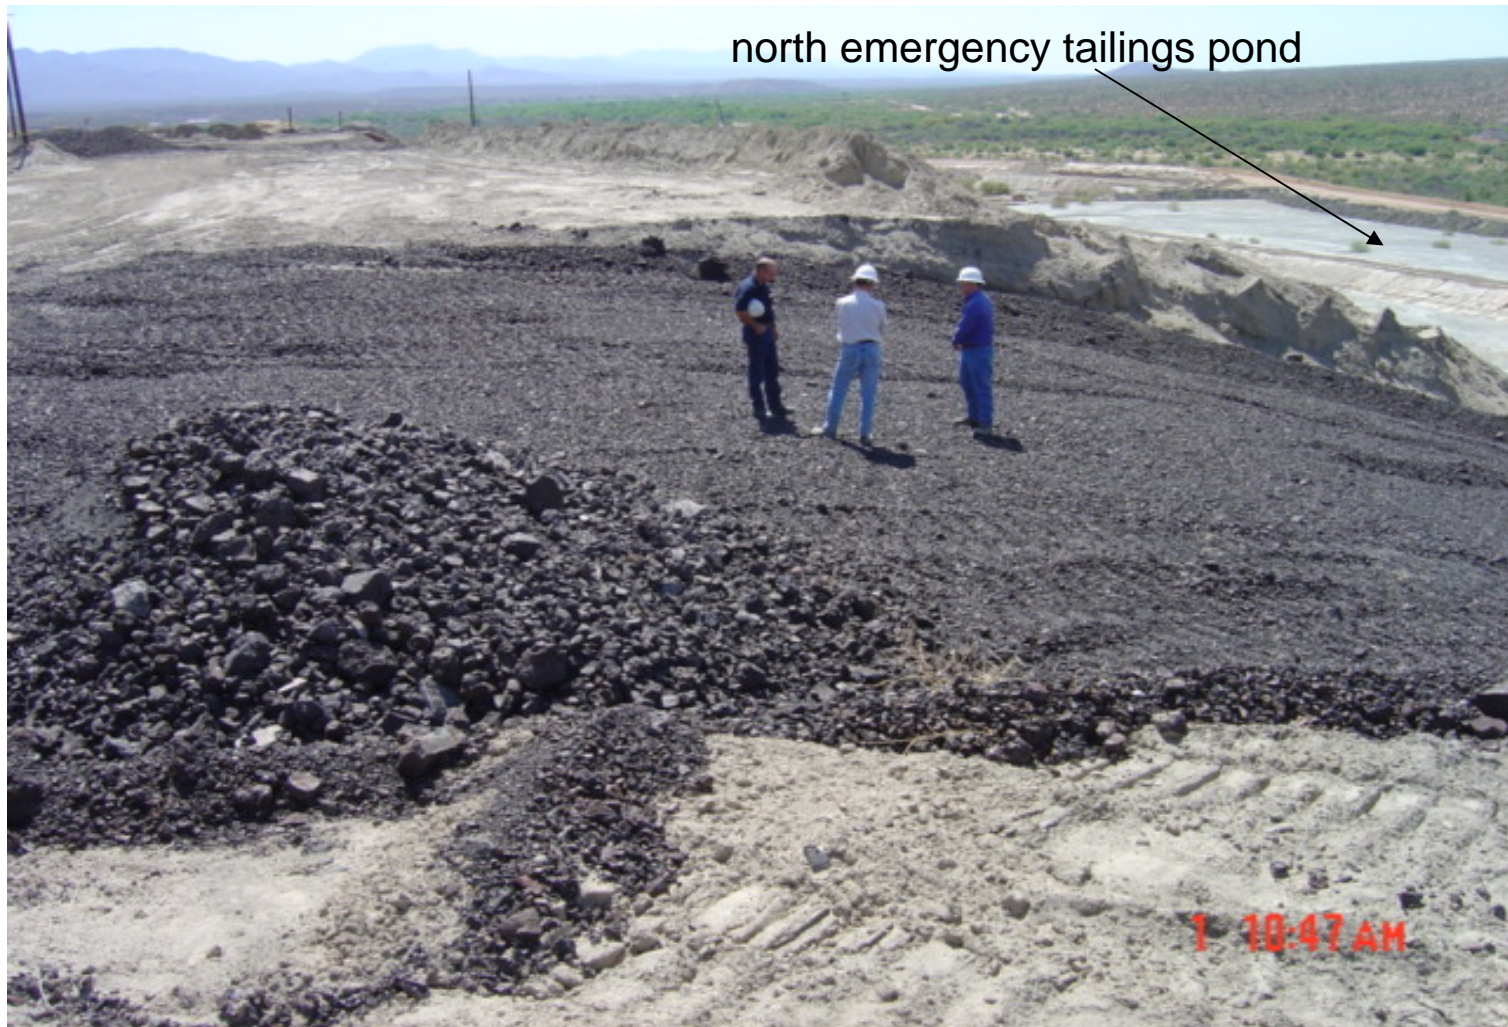
## Photograph 7

Erosion repairs to lower slope near southwest corner of Impoundment AB/BC using crushed furnace slag.

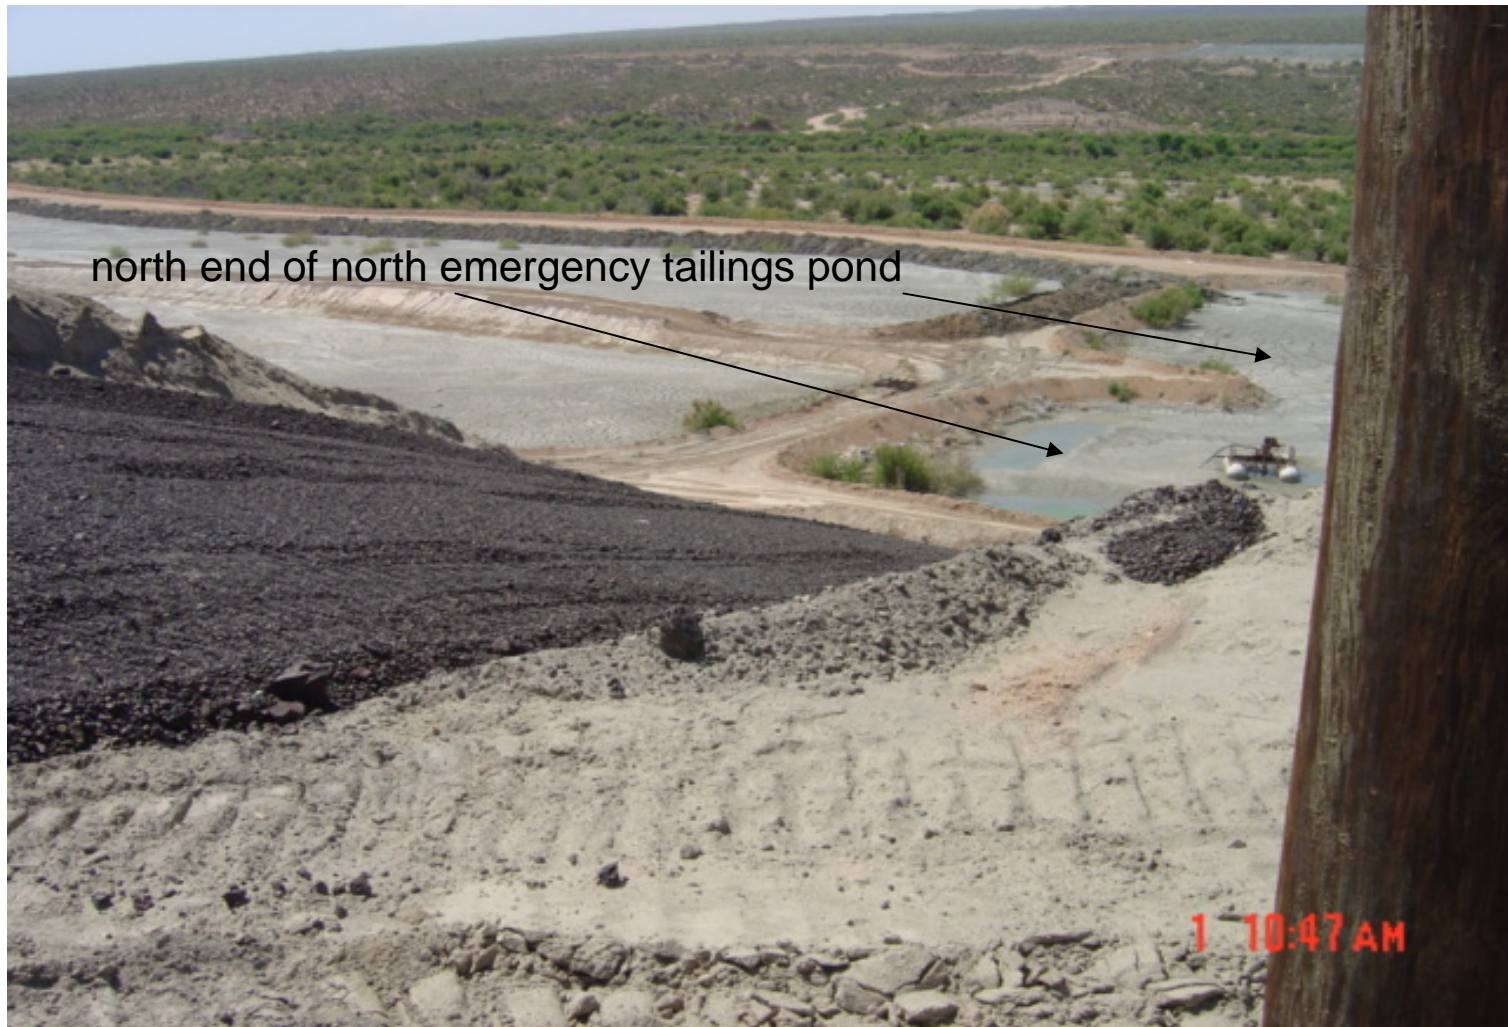
**Photograph 8**

**Erosion repairs to lower slope near southwest corner of Impoundment AB/BC using crushed furnace slag.**

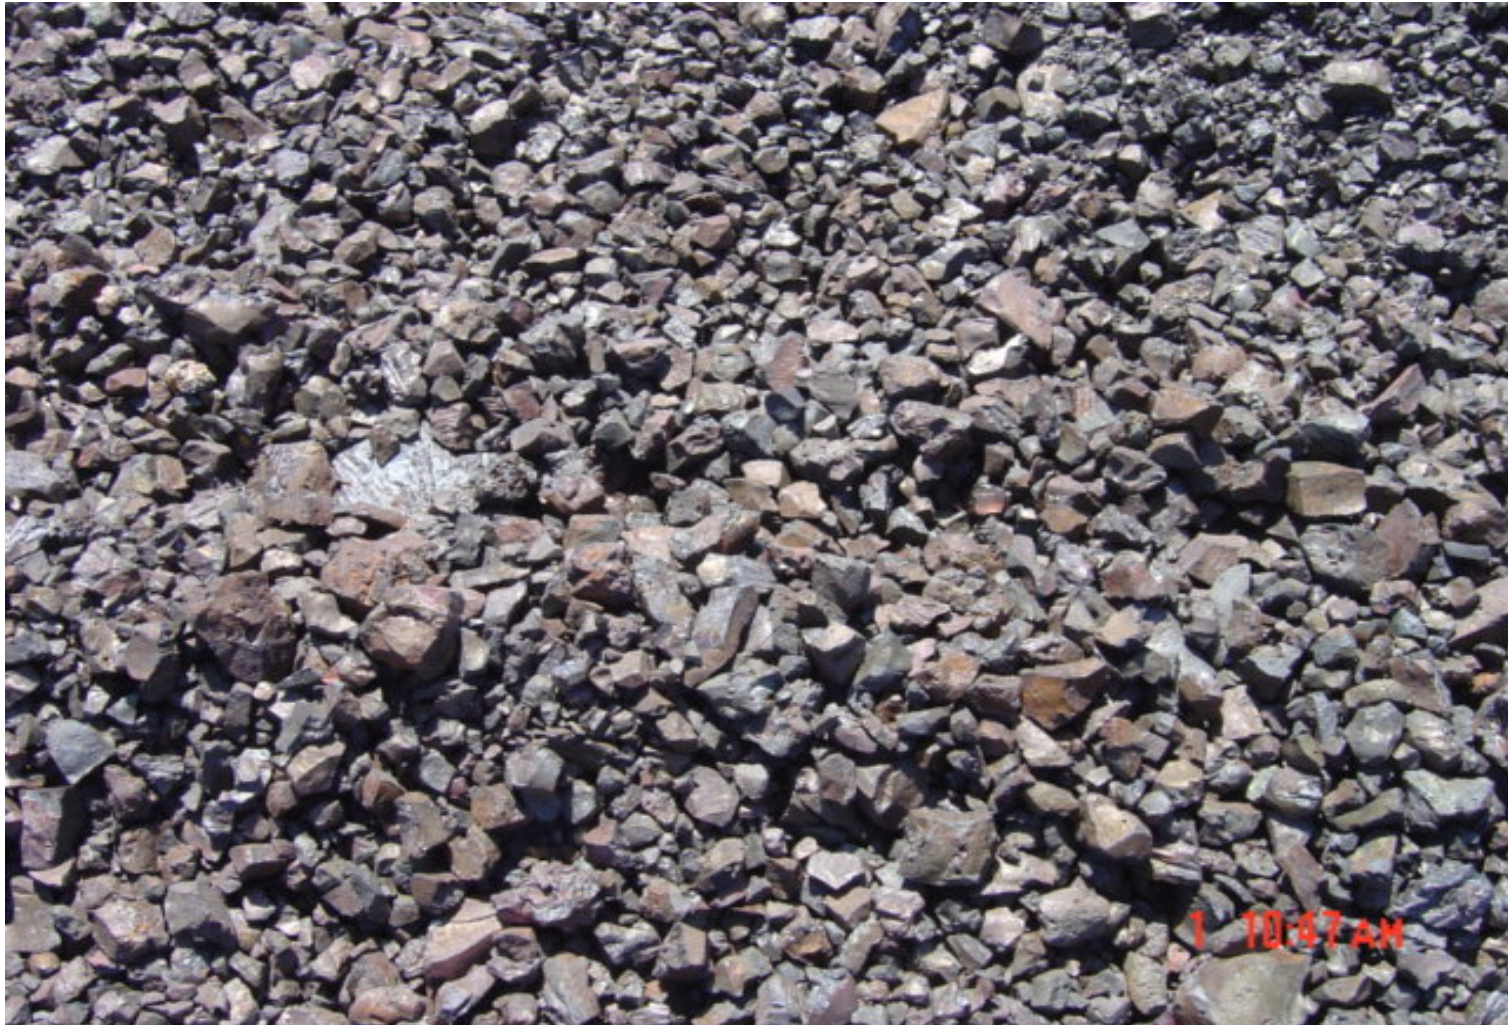
**Photograph 9**

**Closer image of crushed furnace slag used for erosion repairs to lower bench near southwest corner of Impoundment AB.**

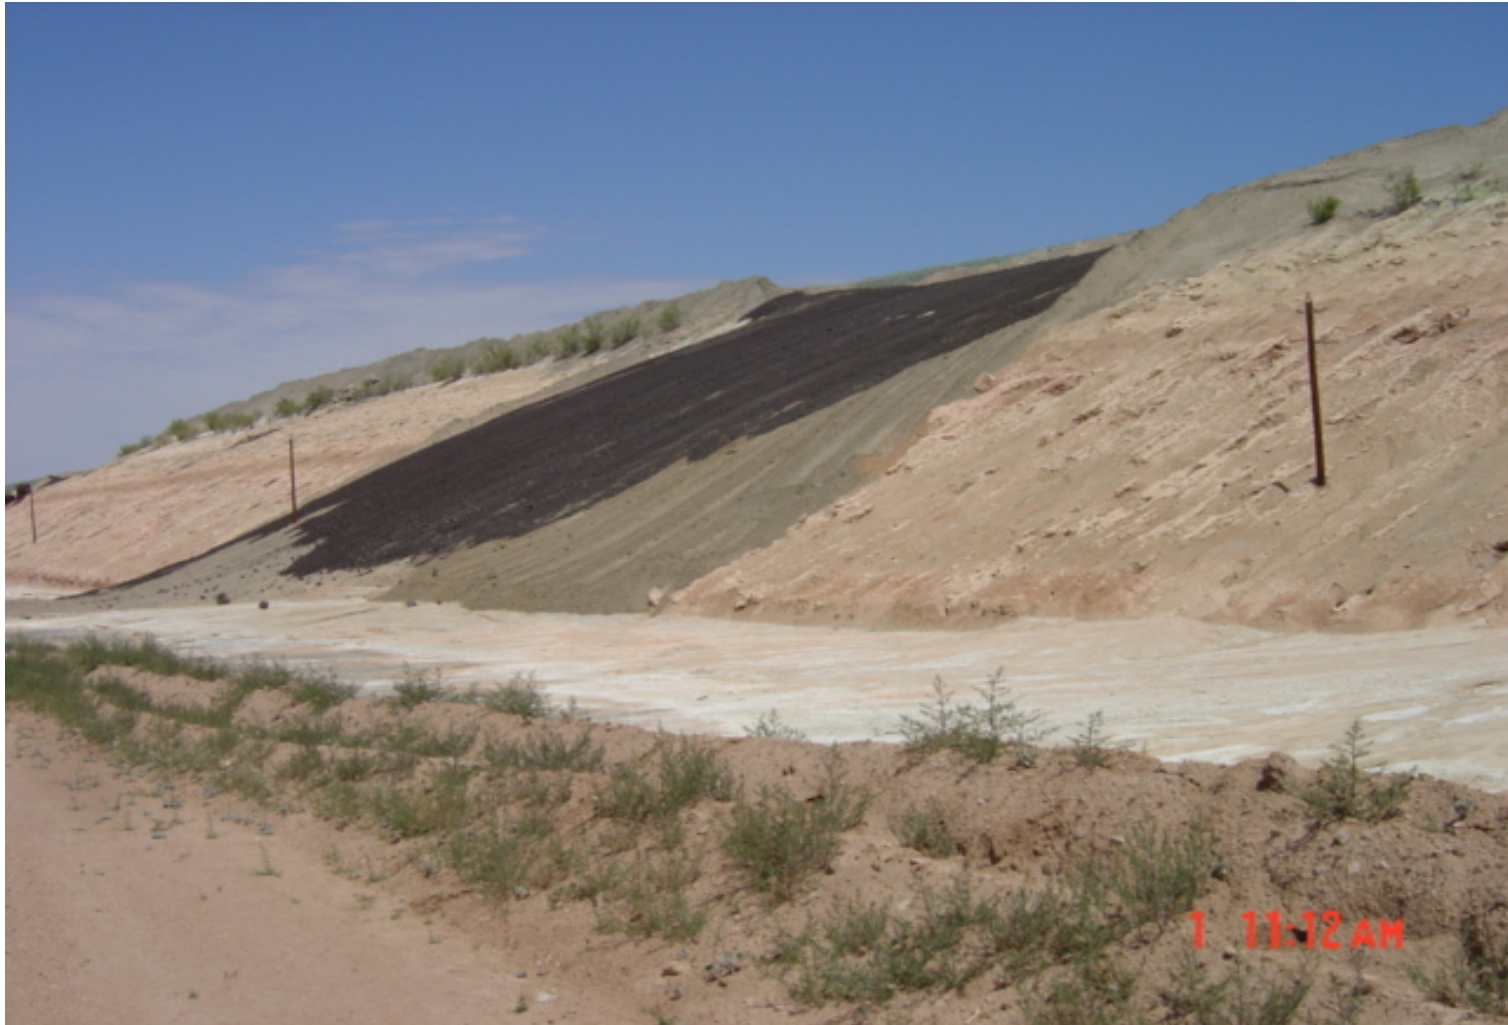
**Photograph 10**

**On-going erosion repairs to lower southwest facing slope of Impoundment AB using furnace slag. Area is near dividing berm between AB and BC impoundments.**

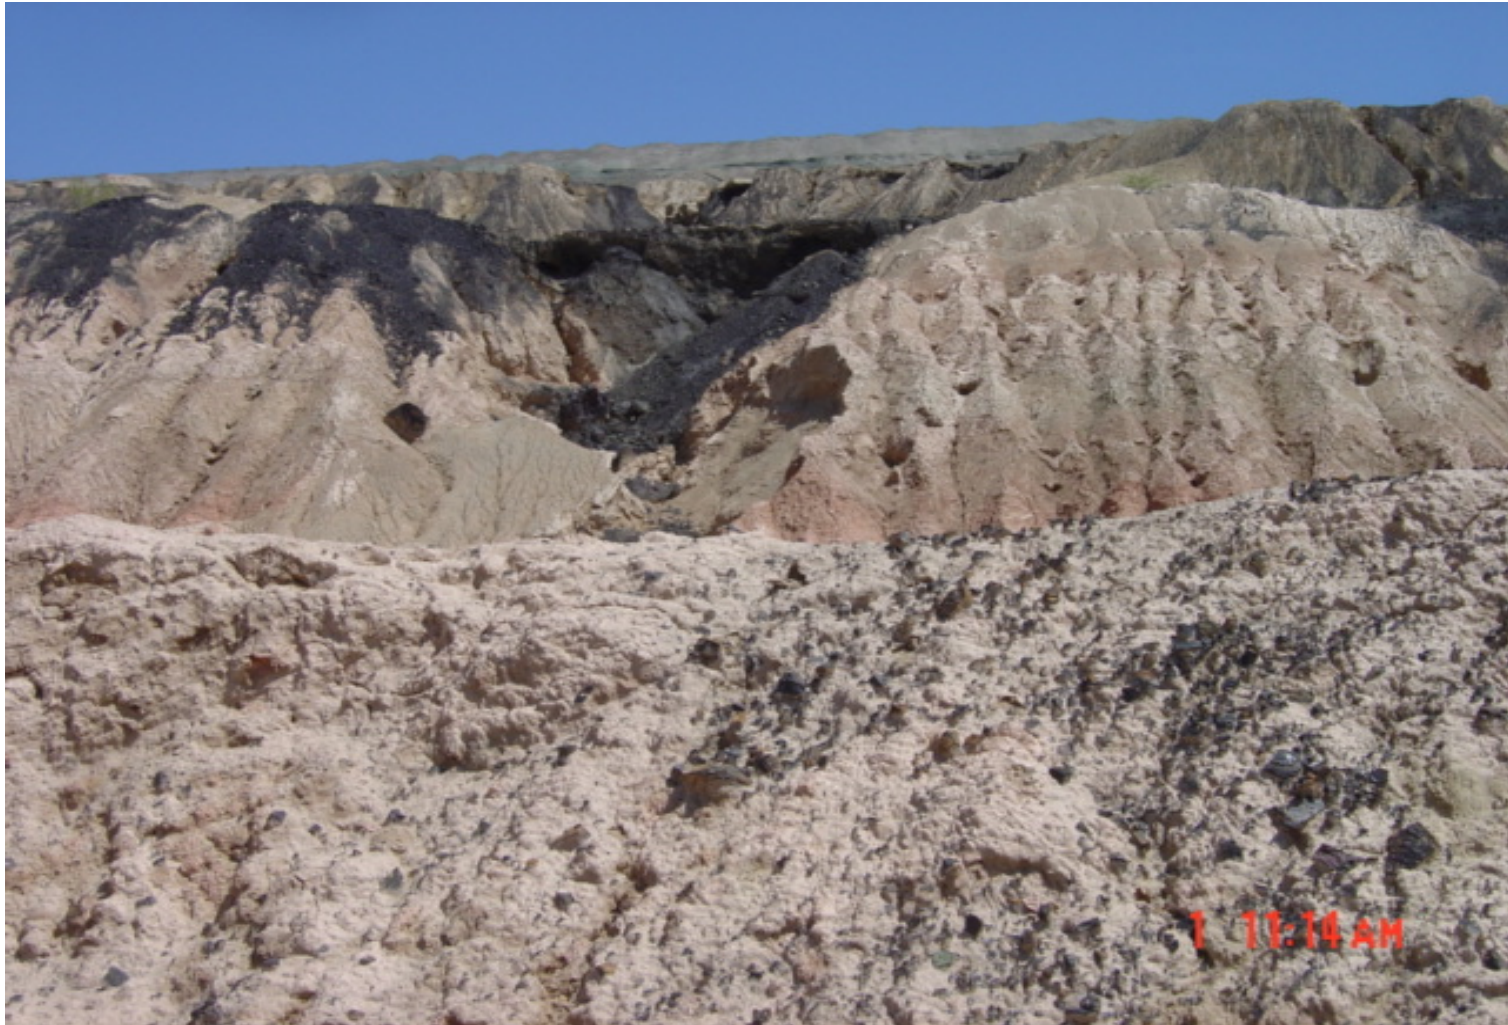
**Photograph 11**

**Severe erosion along crest of lower southwest facing slope of Impoundment AB. Furnace slag appears to be randomly placed for erosion protection.**

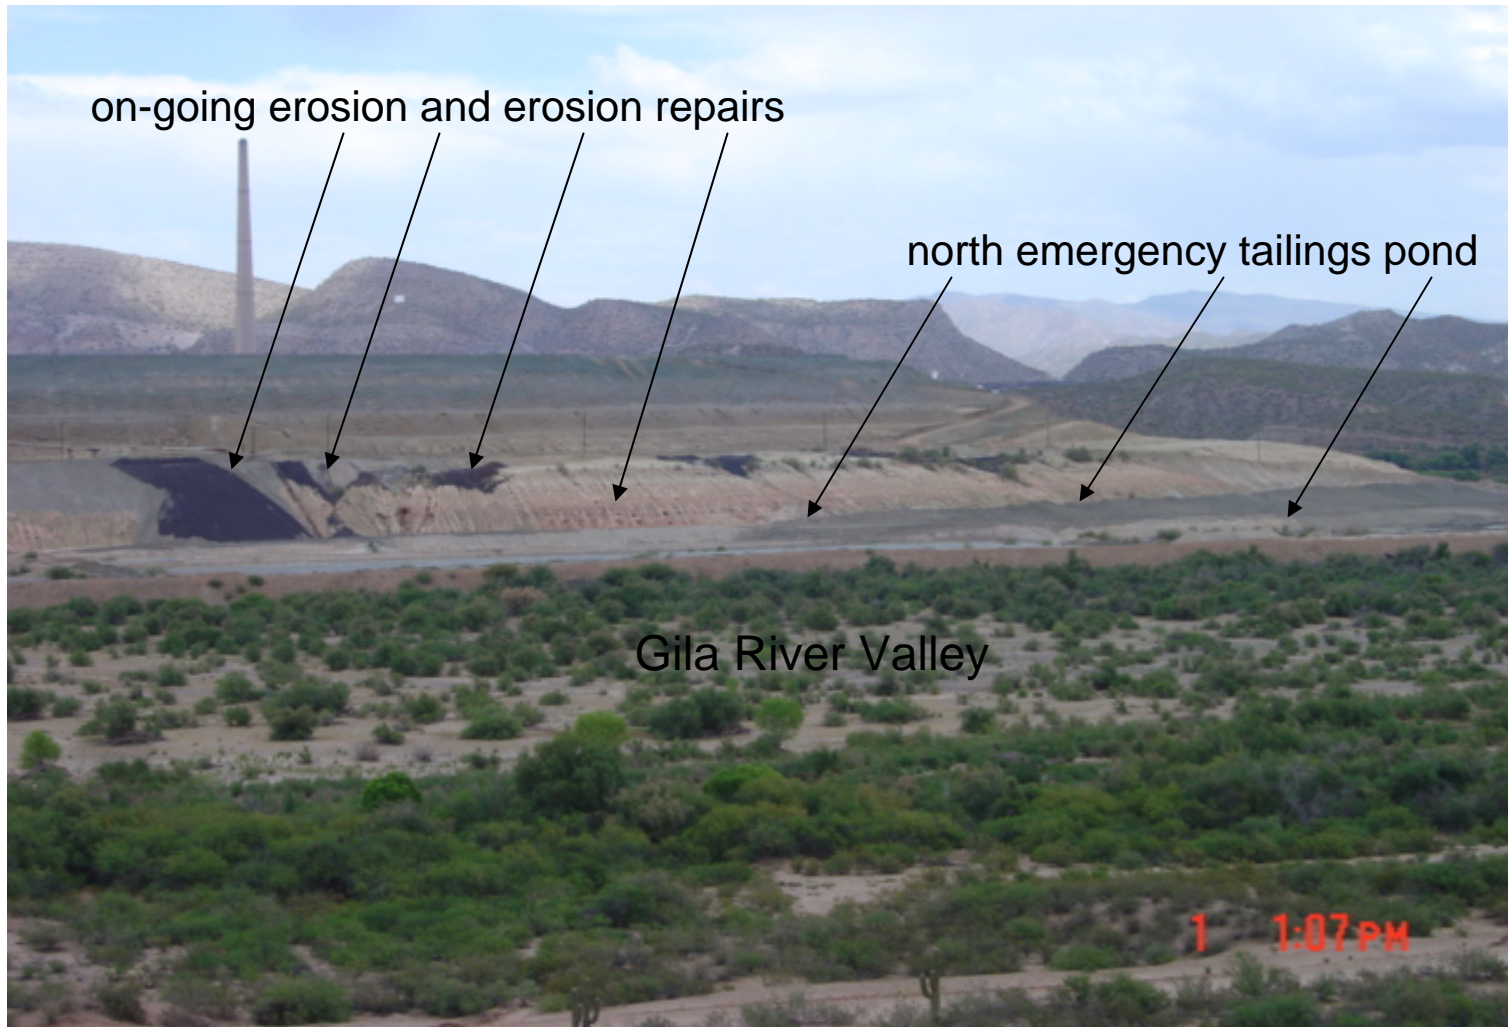
## Photograph 12

Photographs 12 through 17 illustrate panoramic view of southwest (this photo) side and corner of Impoundment AB looking from south to north.

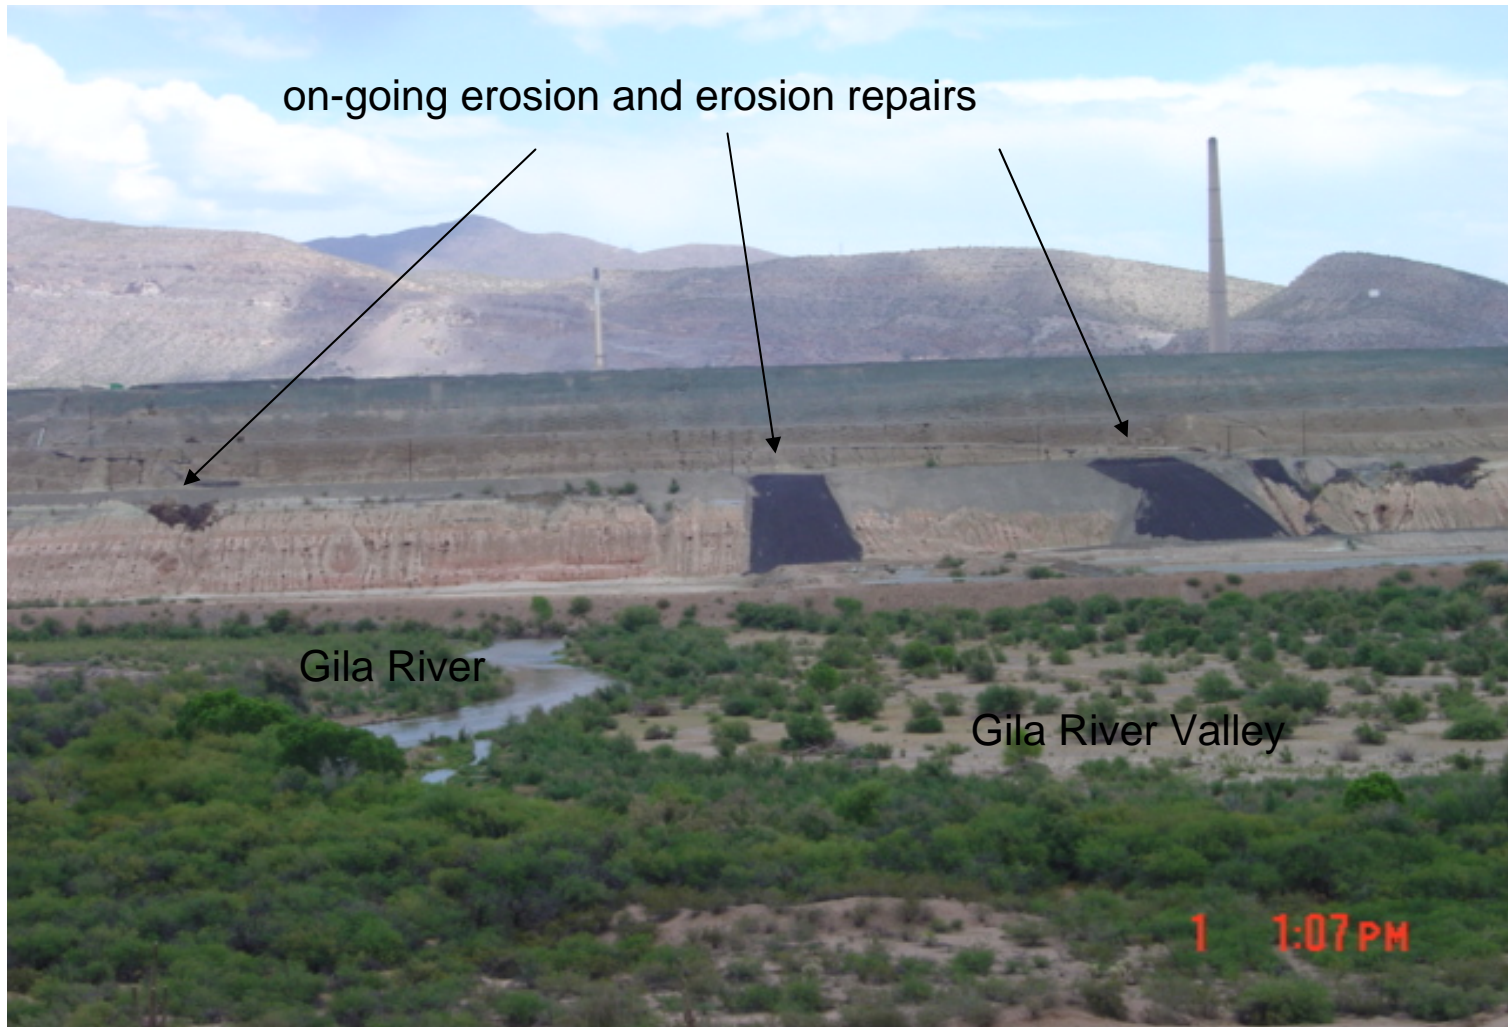
### Photograph 13

Photographs 12 through 17 illustrate panoramic view of southwest (this photo) side of Impoundments AB/BC looking from south to north.

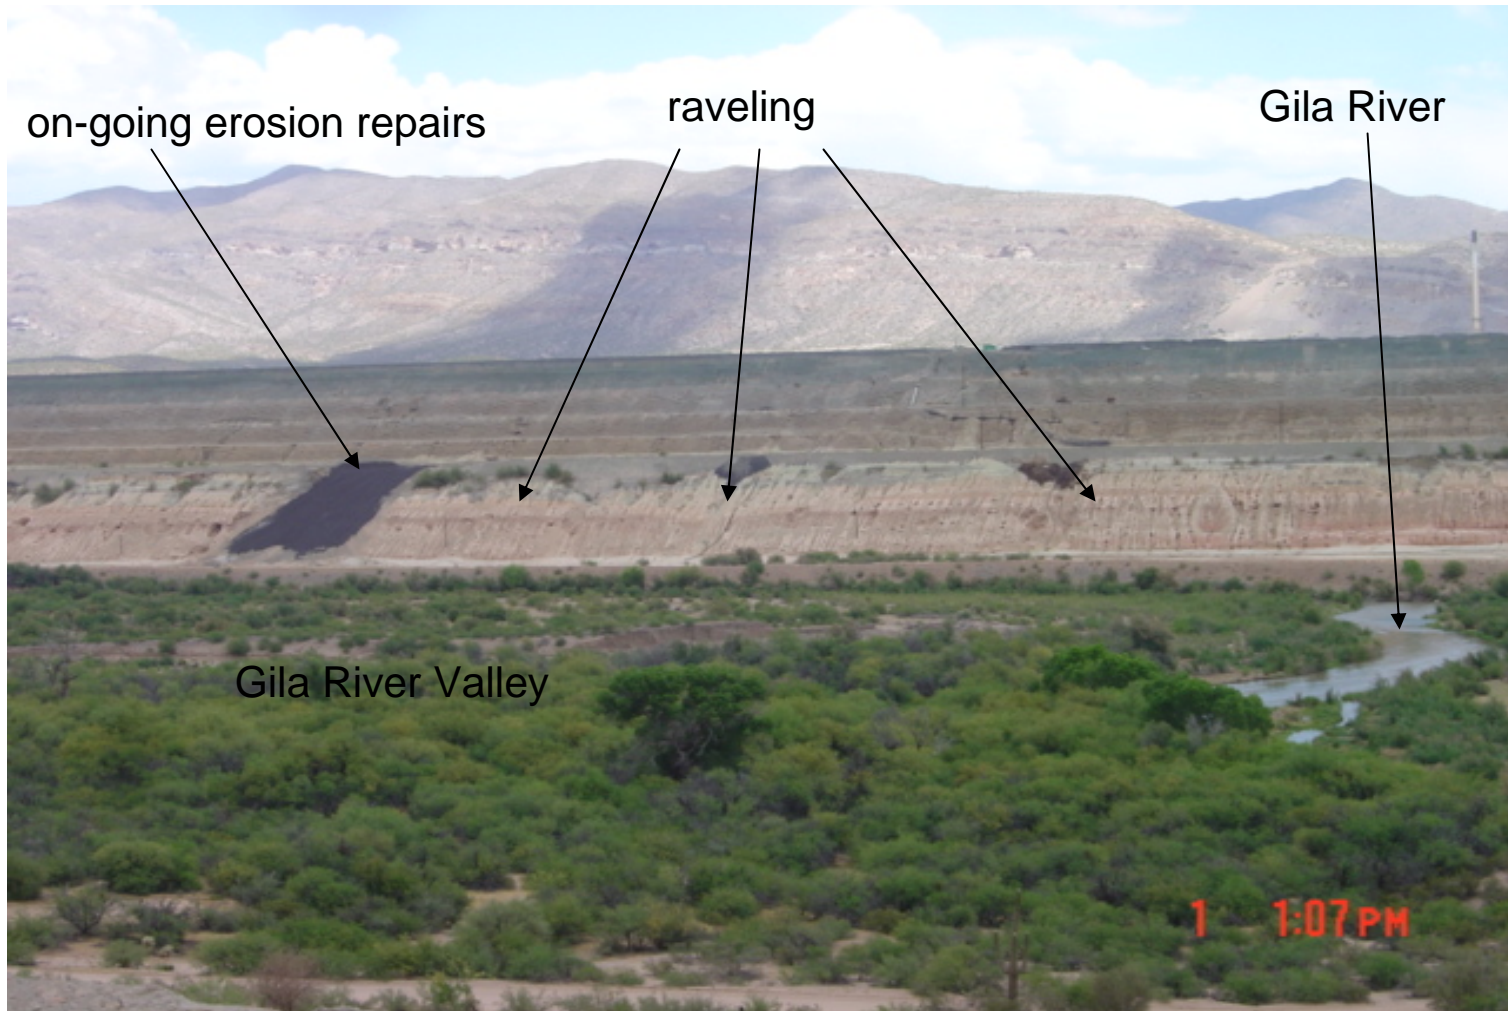
## Photograph 14

Photographs 12 through 17 illustrate panoramic view of southwest (this photo) side of Impoundment BC looking from south to north.
